**CITY OF YUCAIPA  
AGENDA REPORT**

**SUBJECT:** FY24/25 Draft Pavement Management Program

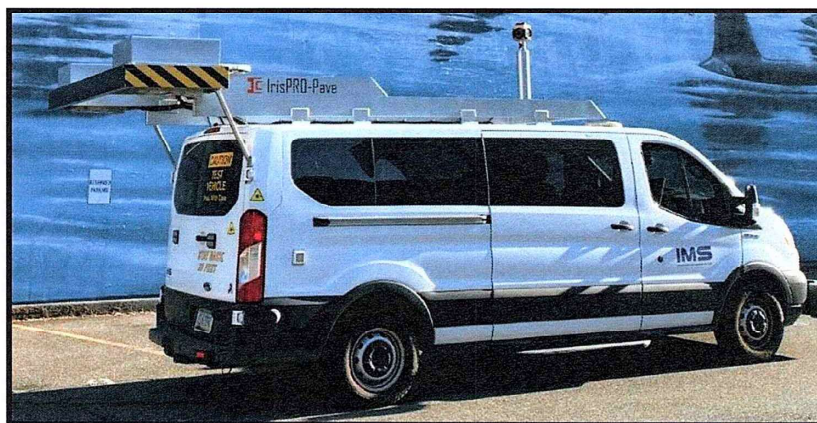
**Figure 1 - IMS Integrated Road Information System platform (IRISpro Pave)**

In May of 2023, IMS Infrastructure Management Services, LP (IMS) utilized a cutting-edge Integrated Road Information System (IRISpro Pave) (**Figure 1**) to capture continuous, high-resolution pavement and right of way images that was used to assess pavement cracking, rutting, and roughness on 202.6 centerline miles of predominantly asphalt roadways in Yucaipa, CA (City). IMS followed the American Society for Testing and Materials (ASTM) D6433 standard to analyze the images and distress data collected by the Road Surface Tester (RST) to determine the Pavement Condition Index (PCI) for each segment of the road. PCI values were recorded to provide an indication of the surface conditions and structural integrity of a pavement.

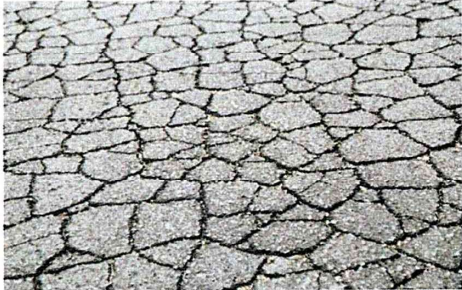
| Distress Type | Pavement Type | Description | Example |
|---|---|---|---|
| <b>Alligator Cracking</b> | Asphalt | <ul style="list-style-type: none"> <li>• Quantified by severity and square footage</li> <li>• Caused by the repeated bending from vehicle loads</li> <li>• Propagate from the bottom, meaning that structural failure has occurred</li> <li>• An LAD with significant impact on the condition score, even at low extents</li> </ul> | |

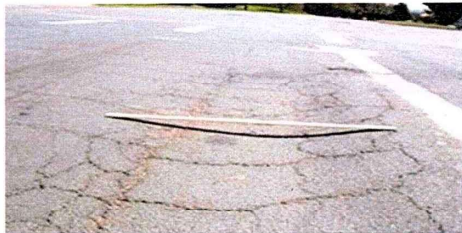
| Distress Type | Pavement Type | Description | Example |
|---|---|---|---|
| <b>Rutting</b> | Asphalt | <ul style="list-style-type: none"> <li>• A minimum depth of ¼ inch</li> <li>• Quantified by their depth and square footage</li> <li>• Caused by the permanent deformation of the pavement and/or subgrade layers</li> <li>• Low densities can have a large impact on the final condition score due to their implication of possible structural failure</li> </ul> | |

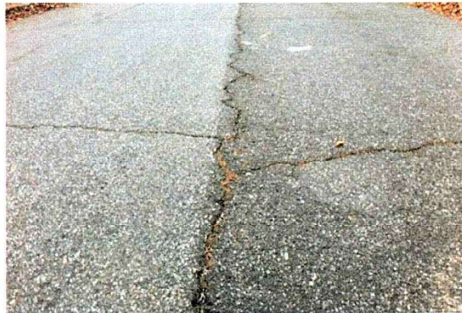
| Distress Type | Pavement Type | Description | Example |
|---|---|---|---|
| <b>Longitudinal &amp; Transverse Cracking</b> | Asphalt | <ul style="list-style-type: none"> <li>• Quantified by their length and width</li> <li>• Results from pavement shrinkage due to natural daily and seasonal temperature cycles, construction issues, or other factors</li> </ul> | |

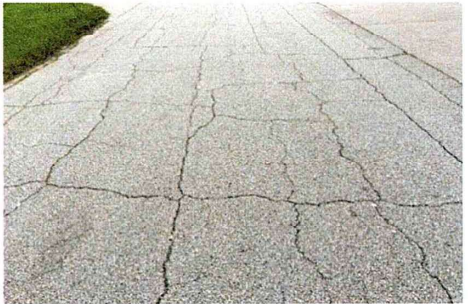
| <b>Block Cracking</b> | Asphalt | <ul style="list-style-type: none"> <li>• Quantified by their width and square footage</li> <li>• Form interconnected longitudinal and transverse cracks</li> <li>• Divides the pavement into rectangular pieces</li> <li>• Results from aging and environmental factors</li> </ul> | |

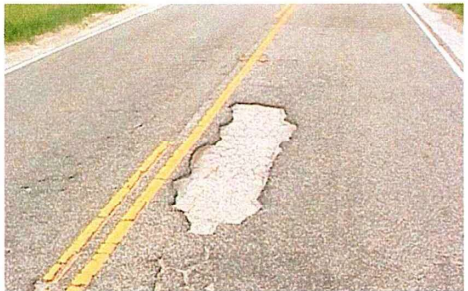
| <b>Raveling</b> | Asphalt | <ul style="list-style-type: none"> <li>• Loss of coarse aggregate on pavement surface</li> <li>• Measured by severity and square footage affected</li> </ul> | |

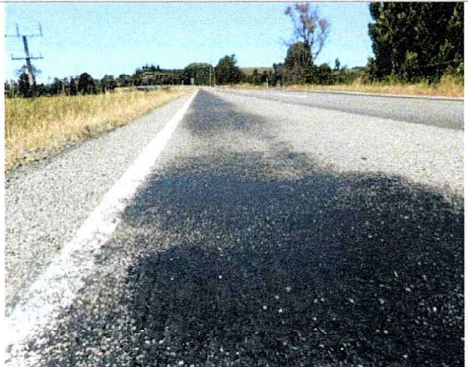
| <b>Bleeding</b> | Asphalt | <ul style="list-style-type: none"> <li>• Presence of free asphalt binder on the roadway surface</li> <li>• Caused by either an excess of asphalt in the pavement or insufficient voids in the matrix</li> </ul> | |

| | | <ul style="list-style-type: none"> <li>• Results in a pavement surface with reduced skid resistance</li> <li>• Measured by severity and square footage</li> </ul> | |

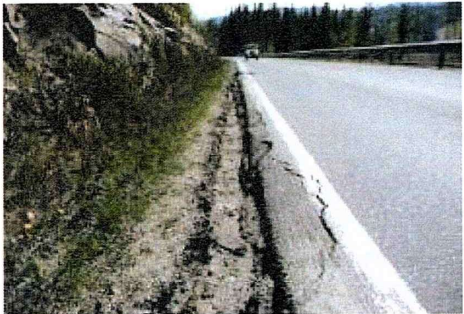
| <b>Edge Cracking</b> | Asphalt | <ul style="list-style-type: none"> <li>• Run parallel to the road, usually within 1 to 2 feet of the outer edge of the pavement</li> <li>• Caused by traffic loading and weakened base conditions resulting from poor drainage</li> <li>• Measured in linear feet</li> </ul> | |

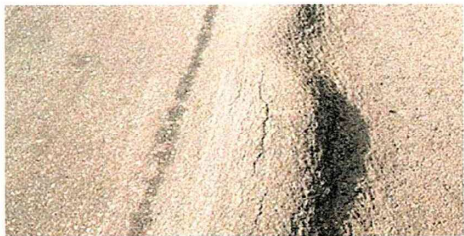
| <b>Distortion</b> | Asphalt | <ul style="list-style-type: none"> <li>• Includes various localized unevenness in the surface</li> <li>• Examples include bumps and sags, depressions, swell, corrugation, and shoving</li> <li>• Caused by several factors, such as construction issues, subgrade failure, mixture failure, environmental influence, etc.</li> </ul> | |

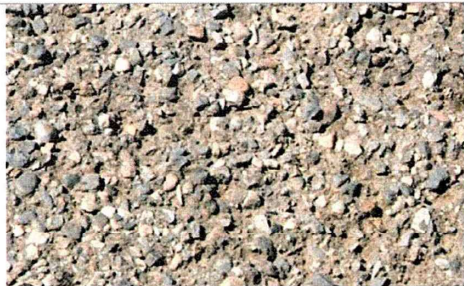
| <b>Weathering</b> | Asphalt | <ul style="list-style-type: none"> <li>• Wearing away of asphalt binder and fine aggregate matrix</li> <li>• Quantified by severity and square footage</li> </ul> | |

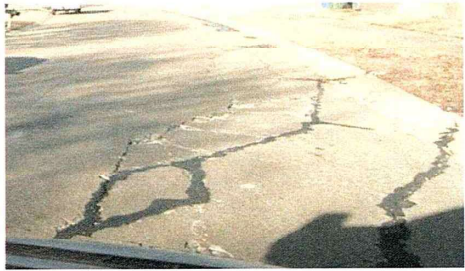
| <b>Divided Slab</b> | Concrete | <ul style="list-style-type: none"> <li>• Slab divided by cracks into four or more pieces</li> <li>• Caused by overloading, inadequate support, or both</li> <li>• Categorized as a severe corner break if all pieces or cracks are contained within a corner break</li> </ul> | |

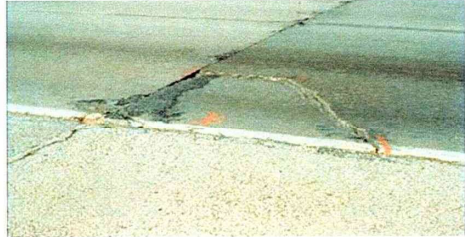
| <b>Corner Breaks</b> | Concrete | <ul style="list-style-type: none"> <li>• Crack that intersects with a joint at less than <math>\frac{1}{2}</math> the slab length</li> <li>• Cracking extends vertically through the entire slab thickness</li> <li>• Typically caused by repeated load on a surface with a failing base</li> </ul> | |

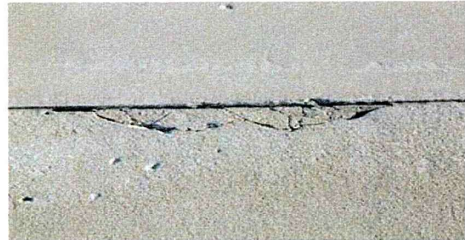
| <b>Joint Spalling</b> | Concrete | <ul style="list-style-type: none"> <li>• A breakdown of the edges of a slab within 2ft of a joint</li> <li>• The depth of the cracking and area affected determine the severity</li> </ul> | |

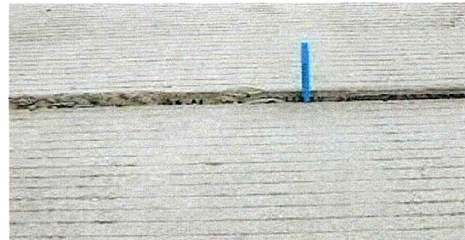
| <b>Faulting</b> | Concrete | <ul style="list-style-type: none"> <li>• Identified by a difference in elevation across a joint</li> <li>• Severe faults have a <math>&gt;\frac{3}{4}</math> inch elevation difference between two adjacent concrete slabs</li> </ul> | |

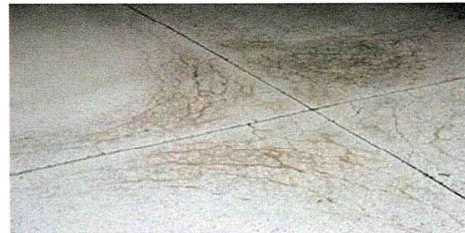
| <b>Durability Cracking</b> | Concrete | <ul style="list-style-type: none"> <li>• Caused by the freeze-thaw expansion of the large aggregate</li> <li>• Breaks down concrete over-time</li> <li>• Typically runs parallel to a joint or linear crack</li> </ul> | |

| | | <ul style="list-style-type: none"> <li>• A high severity “D” crack covers more than 15% of the overall slab</li> </ul> | |

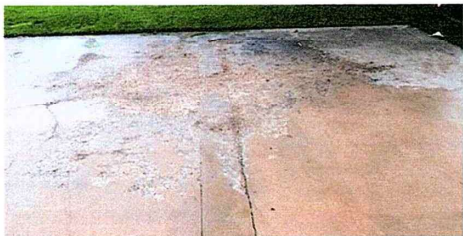
| <b>Scaling</b> | Concrete | <ul style="list-style-type: none"> <li>• A result of the surface layer of concrete being worn away over time by weathering</li> <li>• A ¼ to ½ inch breakdown in the surface</li> <li>• Measured by severity and total area affected</li> </ul> | |

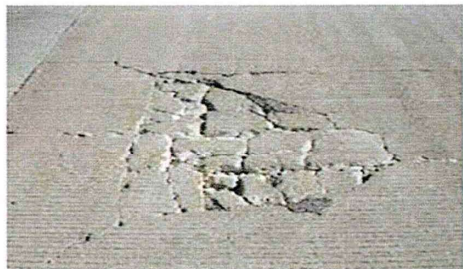
| <b>Punchouts</b> | Concrete | <ul style="list-style-type: none"> <li>• A localized, broken area of the slab</li> <li>• Caused by heavy and repeat loads, inadequate slab thickness, and a deterioration of the base foundation</li> <li>• Measured by severity and number of individual cracks within the distress</li> </ul> | |

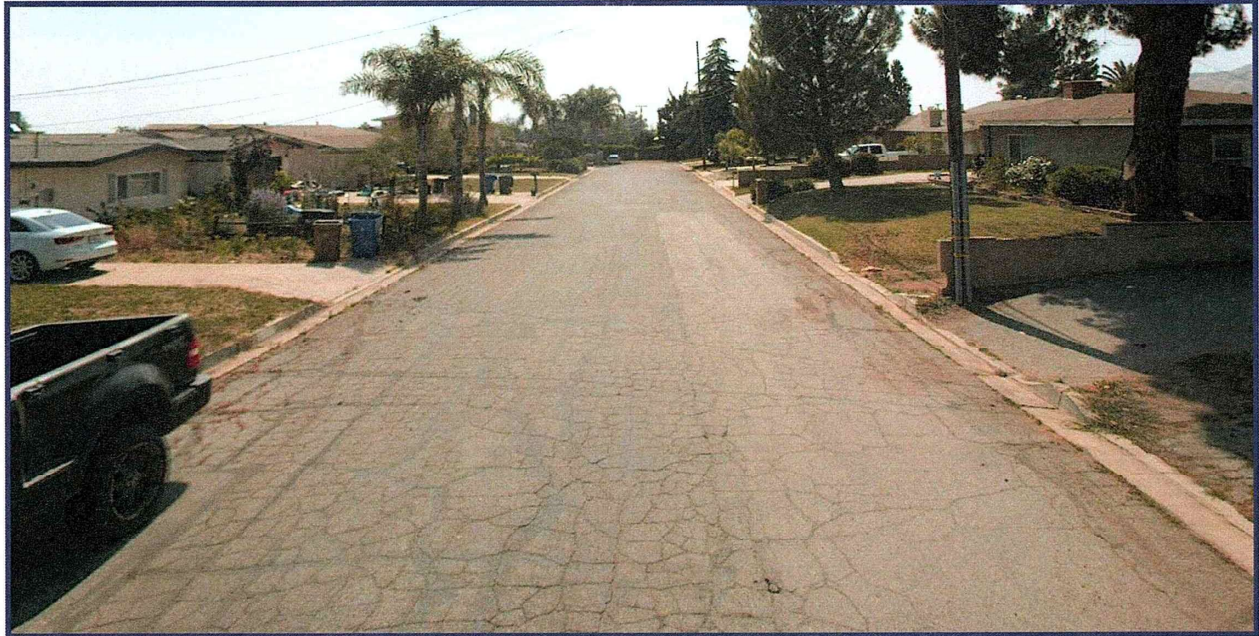
**Ave B from End of Pavement to 2<sup>nd</sup> St (GISID 21276, PCI = 3)** – Rated as *Very Poor*, this street displays a large quantity of alligator cracking severe enough to suggest that the pavement structure is inadequate for current traffic loads. The rehabilitation of roads in this condition through a mill and overlay is generally ineffective, as the failures usually extend to the bottom of the pavement layer. Streets in this condition require rehabilitation that involves removal and replacement of the asphalt layer, base stabilization, or complete reconstruction based on design requirements.

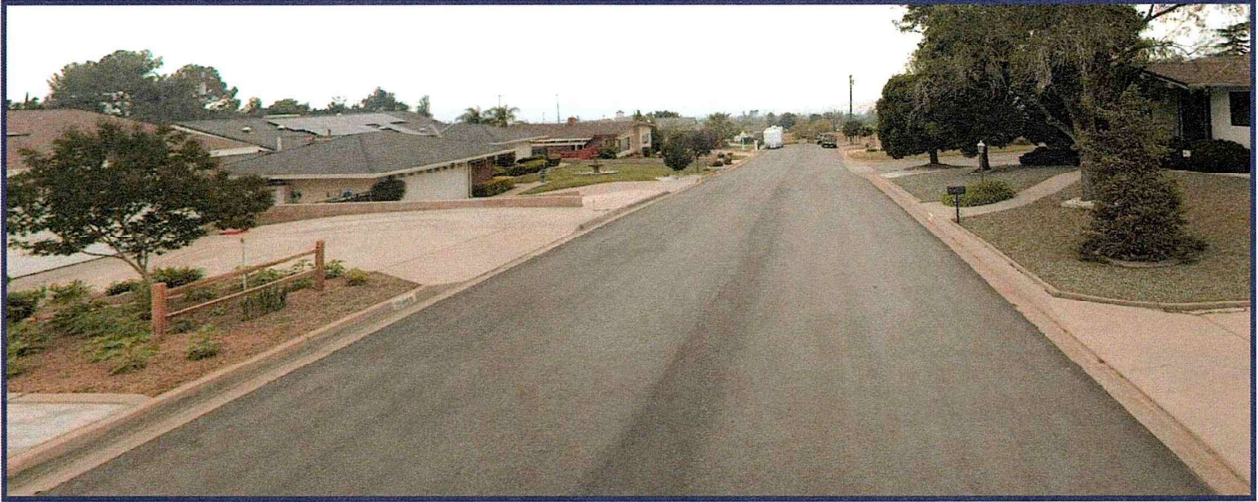
**Cornell Dr from Grant Dr to Holmes St (GISID 21195, PCI = 97)** – Rated as Excellent, this pavement displays little to no surface distresses. The ride is smooth, and the surface and the base are intact. Excellent roads should be periodically assessed for crack development that would trigger routine maintenance activities.
